Inspection Report - Special

Mine Name: Genwal

EVALUATION AND CONTROL OF COAL BUMPS

Office of Mine Safety and Health Research
National Institute for Occupational Safety and Health
Centers for Disease Control and Prevention
U.S. Department of Health and Human Services

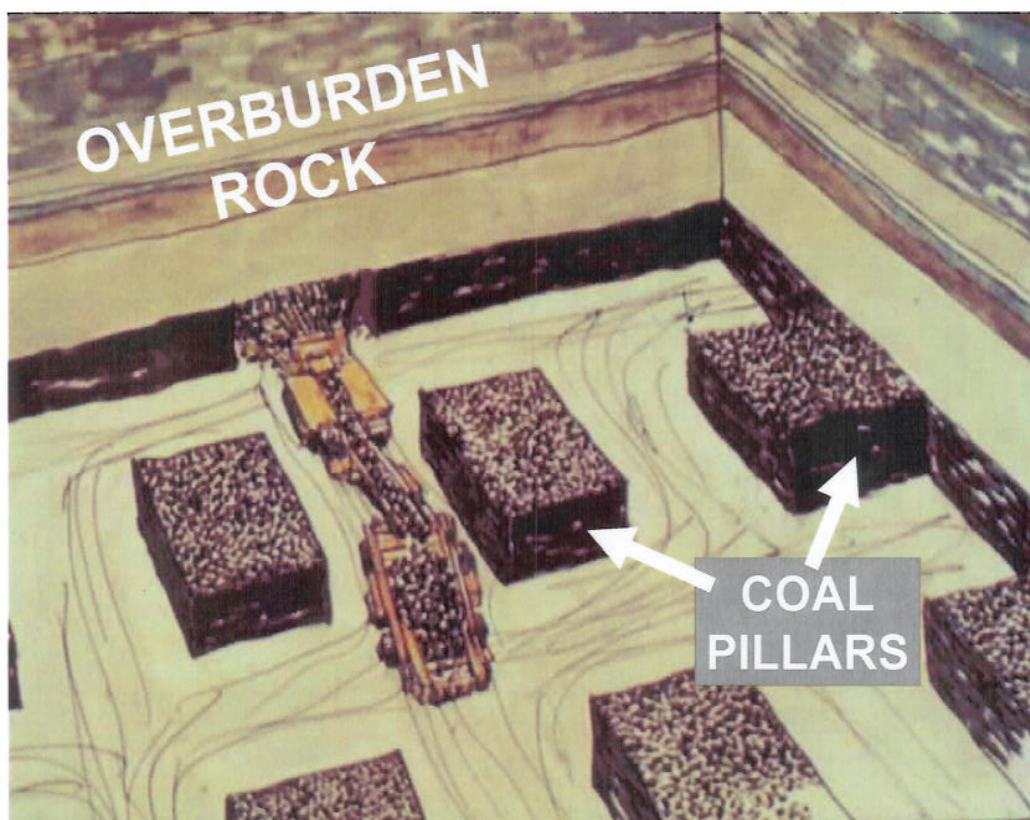
Figure 1. Coal pillars support the great weight of the overburden and provide “Global Stability.”

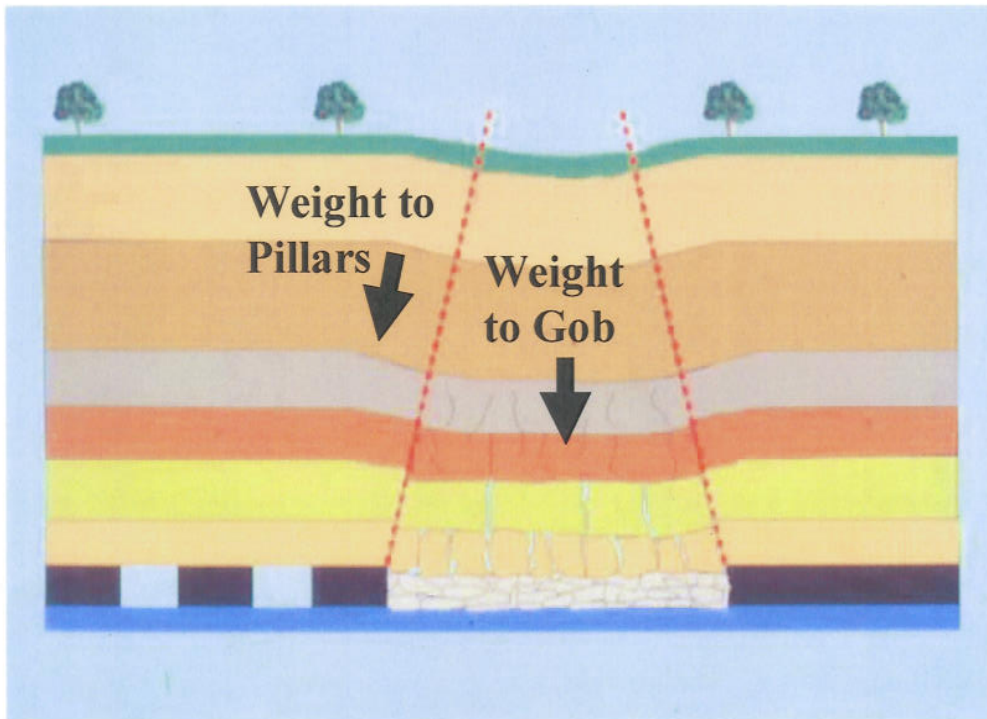
Figure 2. Full extraction mining creates “gob areas” and causes additional “abutment loads” to be transferred to the pillars.

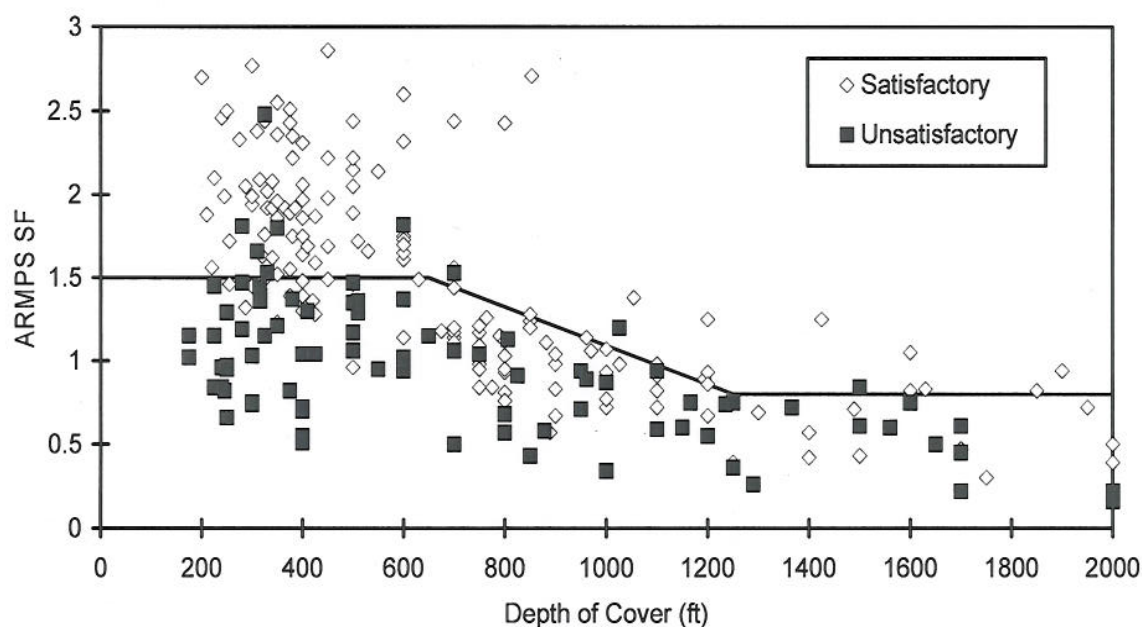
Figure 3. The ARMPS case history data base, including deep cover cases, and showing the suggested pillar SF.

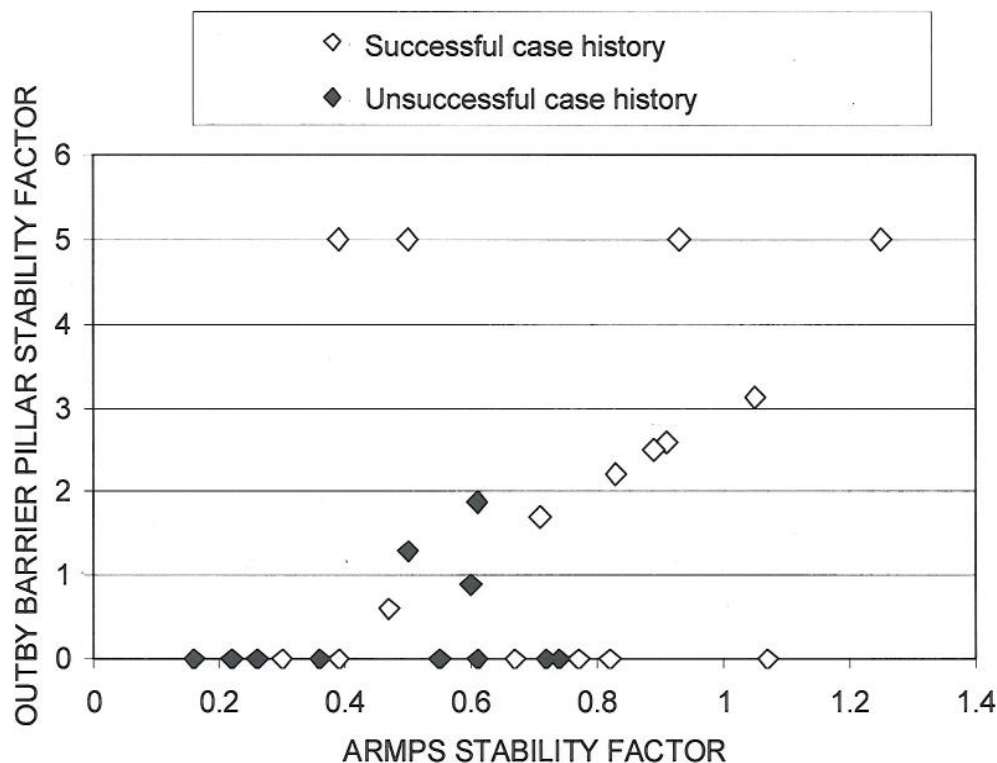
Figure 4. The ARMPS deep-cover, strong roof data base, showing the importance of using barrier pillars for stability. Most of the unsuccessful cases are bumps.
